# Allergic Reaction to Suture Material After an ICD Procedure: Device Infection Mimicry

CORY M. TSCHABRUNN, C.E.P.S.,\* MISHA ROSENBACH, M.D.,† NIMROD LAVI, M.D.,\* and JOSHUA M. COOPER, M.D.\*

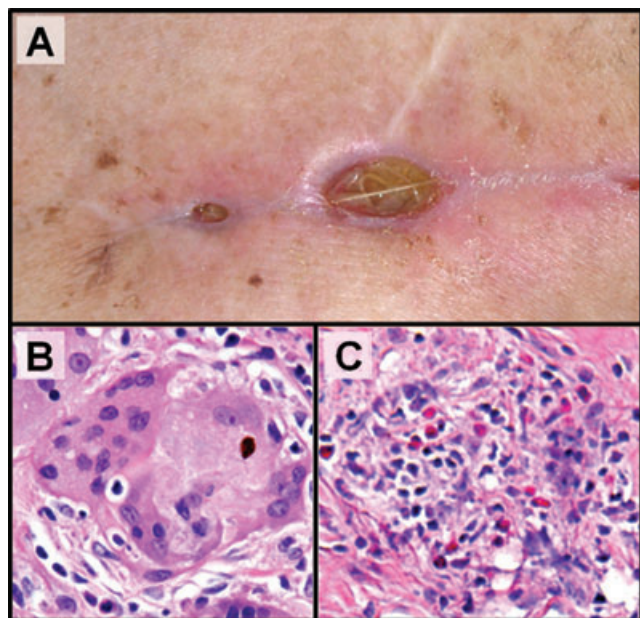
revision also in 2008 for slight migration of the ICD generator with subjective discomfort. In each case, the device wound was closed in 3 layers with Polysorb absorbable suture. After the first 2008 procedure, the wound was slow to heal, but complete healing was noted after 4 weeks. After the second procedure in 2008, however, the wound failed to heal over several weeks, with persistent clear drainage, skin ulcerations, and visible suture strands (Fig. 1A). Given the multiple device procedures and lack of wound healing, a device infection was presumed and the patient was scheduled for a full device and lead extraction.

The patient was brought to the electrophysiology laboratory, placed under general anesthesia, and femoral venous and arterial access was obtained, as per our lead extraction protocol. After sterile preparation of the pectoral site, an elliptical skin incision was made around the wound to excise the devitalized skin. Soft, liquefied tissue was found along the length of the wound wherever suture strands remained, including underneath superficial bridges of healed skin, with copious serous drainage noted. Below the dermis, a healthy base of granulation tissue was found, without purulence and without any obvious exposure to or communication with the underlying device and lead hardware. Because of the unusual appearance of the tissue that was in contact with suture material, and the lack of any visual extension of the ulcerating process to the deeper tissues or device pocket, a reaction to the suture material was hypothesized. The device pocket was not opened, all suture material was removed from the surgical site, the excised tissue fragments were sent for culture and pathologic evaluation, and the wound was left to heal by secondary intention. To accelerate wound healing, a vacuum dressing system was used (Fig. 2A). Negative pressure wound therapy involves the fitting of a foam dressing that is cut to match the wound dimensions, application of an occlusive, adhesive sheet over the foam dressing, and the incorporation and attachment of tubing and a negative pressure pump system that delivers continuous subatmospheric pressure to the wound environment. The vacuum dressing system promotes wound healing by secondary intention by reducing edema, promoting perfusion and granulation tissue formation, and removing exudates and infectious material.

**Figure 1.** A: Photograph of the nonhealing device wound, 4 weeks after a prior pocket revision procedure. Suture strands and serous fluid are seen within ulcerations along the wound. B: Microscopy example of a multinucleated giant cell from the tissue specimen that was sent for pathologic evaluation. C: Microscopy example of inflammation with many eosinophils (orange-red staining) from the same specimen.

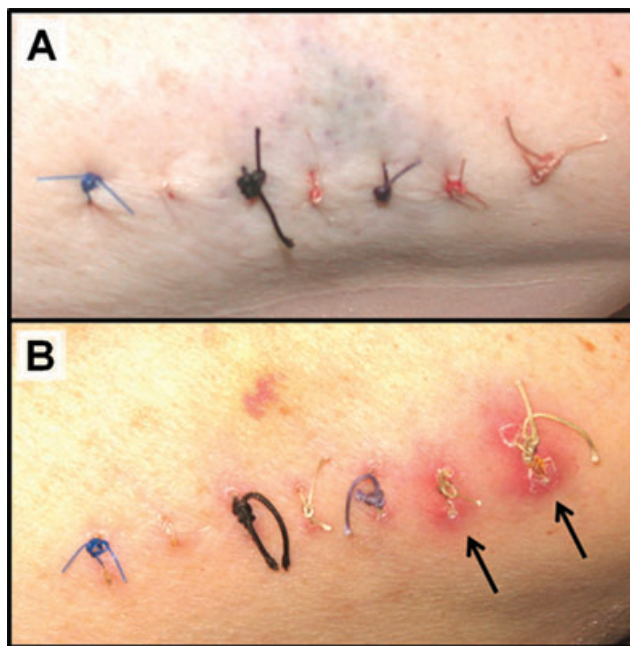
To investigate the possibility of an allergic response to suture material, a dermatology consult was requested, and skin testing was recommended. After informed consent was obtained for skin testing, the right upper inner arm was anesthetized with 1% lidocaine local injection, and a variety of suture materials were placed to look for an allergic response (Fig. 3A). After 2 weeks, only the 2 Polysorb sutures demonstrated an erythematous reaction, but not the other suture materials tested (Fig. 3B). Pathologic analysis of the ICD wound excised tissue revealed both giant cells (Fig. 1B) and numerous eosinophils (Fig. 1C), consistent with an allergic response. After several weeks of careful wound care, including serial removal and refitting of the foam material that is used in the vacuum dressing system (Fig. 2B), fol-

**Figure 3.** A: Photograph of 7 sutures in the right upper inner arm, placed for allergic skin testing. From left to right, the sutures are 3-0 Prolene, 5-0 Polydioxanone (PDS), 0 Sof silk, 4-0 Vicryl, 2-0 Vicryl, 4-0 Polysorb, and 2-0 Polysorb. B: Photograph of the 7 skin-testing sutures at 2 weeks, demonstrating an erythematous reaction only to the 2 Polysorb sutures (arrows).

In the dermatology literature, allergy to the colored dye in suture has been reported, and to specific suture types,<sup>3-6</sup> but this phenomenon has not been described before in the setting of CIED implantation, which has unique implications because of the presence of permanent device hardware. Skin testing can determine which types of suture may be used safely, which is of critical importance for future surgical procedures where suture is needed for wound closure. An allergy to Polysorb suture was documented in this patient's medical record, and alternative absorbable suture material

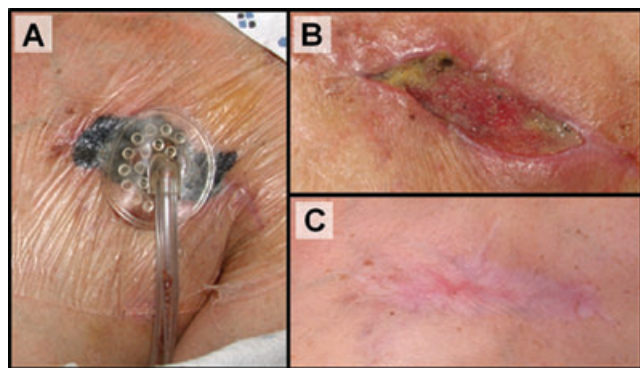
**Figure 2.** A: Photograph of the vacuum dressing system, showing the black foam cutout in the wound, and the overlying surface adhesive and vacuum tubing. B: Photograph taken at the time of a dressing change, showing healthy granulation tissue in the wound, and a few small black foam particles from the dressing. C: Photograph of the fully-healed wound.

lowed by simple gauze dressings, the wound fully healed (Fig. 2C).
