## Journal of Clinical Orthopaedics and Trauma

## Review article

## Nickel allergy to orthopaedic implants: A review and case series

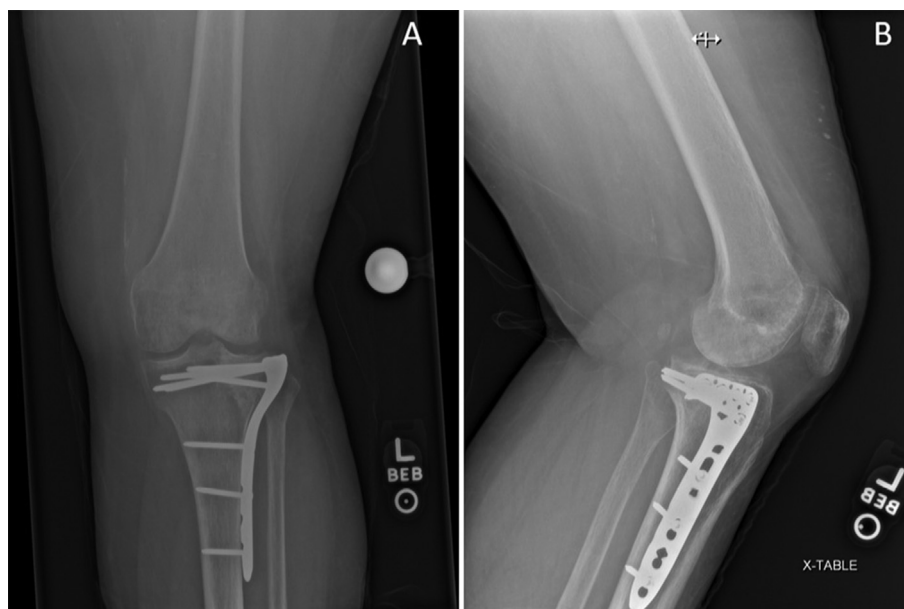
Fig. 1. Anteroposterior (A) and lateral (B) views prior to hardware removal.

She was seen 28 weeks postoperatively, and her wound had been draining for a couple weeks. Other than occasional stiffness in the morning, she had minimal pain/discomfort. There were no radiographic signs of failure or osteomyelitis (Fig. 1). Due to the length of time since surgery, the plan was to evaluate her for deep

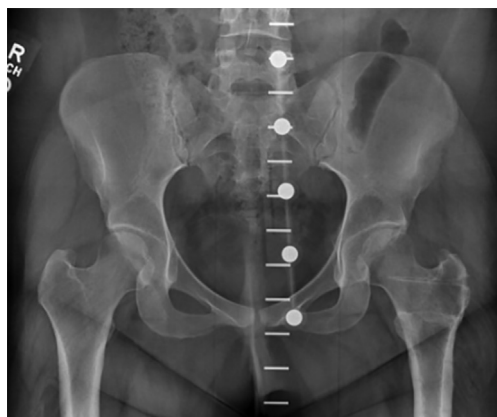
Fig. 9. Anteroposterior view of left hip following hardware removal.

Six weeks later the patient's radiographs showed that she was healing well (Fig. 9), and her incisions were no longer draining. She was told to work on strengthening and stamina. Eight weeks later, she finished physical therapy.
