# Usage of Hydrocolloid-Based Plasters in Patients Who Have Developed Allergic Contact Dermatitis to Isobornyl Acrylate While Using Continuous Glucose Monitoring Systems

Journal of Diabetes Science and Technology  
1–4

DOI: 10.1177/1932296819876964

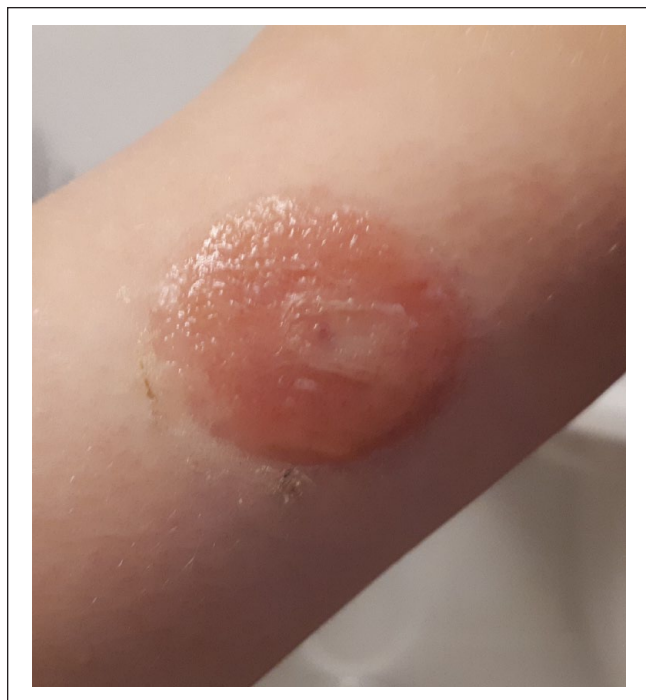
**Figure 1.** Allergic contact dermatitis of a patient with type I diabetes developed after using an intermittent scanning continuous glucose monitoring system.

least some patients develop a severe contact dermatitis with strong redness, scaling, and sometimes exudation. Mostly, in these patients, itching is so intensive that they have to tear up the glucose sensor of this iscCGM system after a few days (Figure 1).

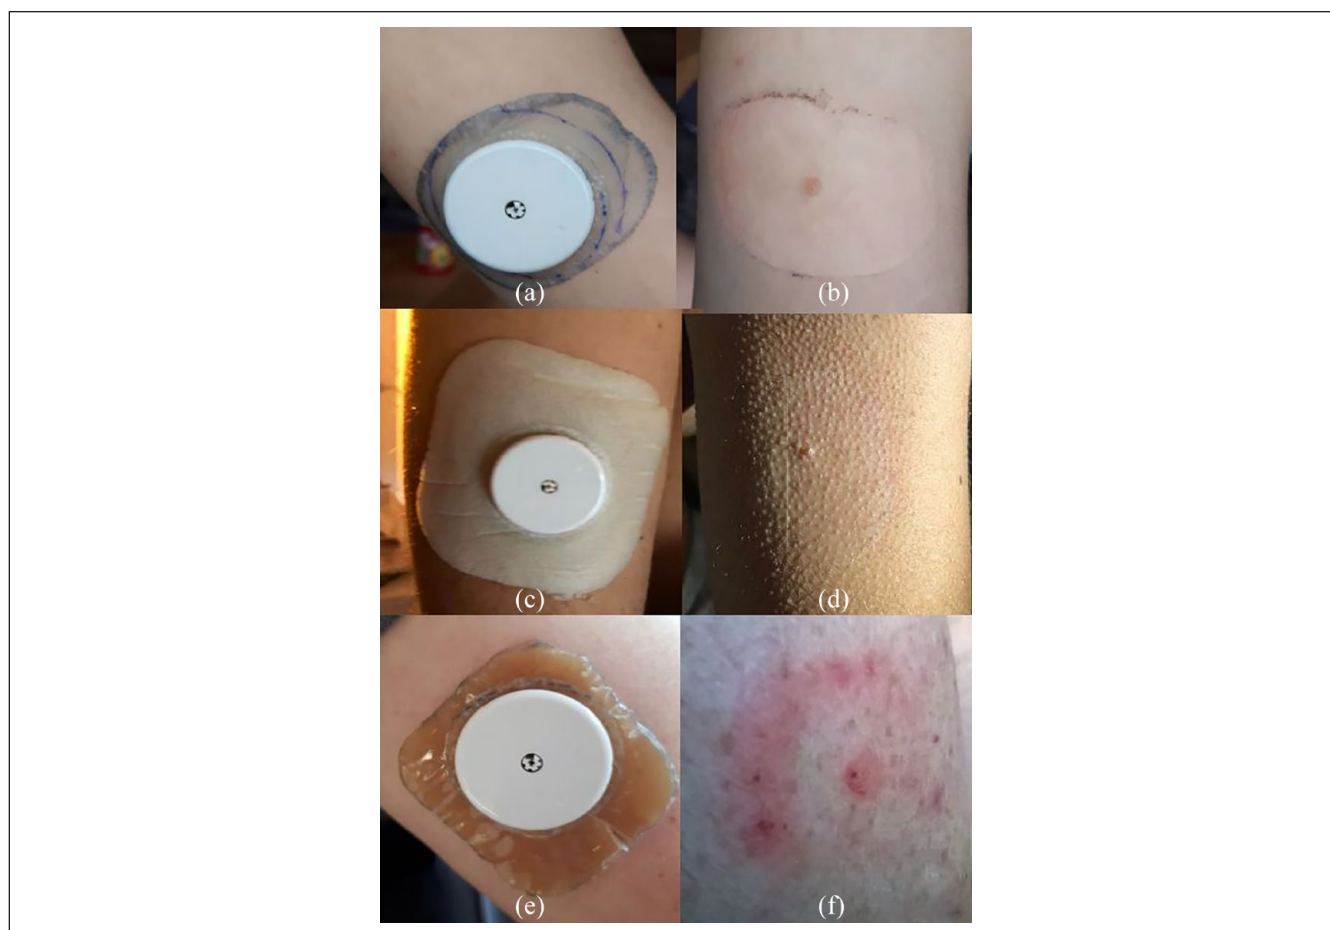
**Figure 2.** (a) Hansaplast under the glucose sensor of the intermittent scanning continuous glucose monitoring system and (b) skin area after 14 days. (c) Cutimed Hydro B under the glucose sensor of the intermittent scanning continuous glucose monitoring system and (d) skin area after 14 days. (e) Stomahesive under the glucose sensor of the intermittent scanning continuous glucose monitoring system and (f) skin area after 14 days.

In order to block an ACD reaction when the glucose sensor of the iscCGM system was applied, patients 1, 2, 3, 4, and 5 were provided with Hansaplast blister plasters from Beiersdorf AG (Hamburg, Germany), patients 6 and 7 with Cutimed Hydro B from BSN medical (Hamburg, Germany), and patient 8 with Stomahesive baseplate from Convatec (Deeside, United Kingdom). These plasters are acrylate-free and are not permeable to allergens like IBOA or DMAA. They are placed directly on the skin, whereas the sensor sticks on these plasters. Thus, they function as protection barrier intending to prevent potential allergens from diffusing out of the sensors' own adhesive or its plastic case toward the skin.

time of 14 days (Table 1). Patient no. 3 (with Hansaplast) had to remove the glucose sensor earlier, because after 11 days the plaster did not stick strong enough anymore to the skin. Patient no. 8 (with Stomahesive) experienced some itching and redness at the edges of the plate, yet, the symptoms were only from time to time.

In the small number of patients studied by us, the Hansaplast blister plaster worked well with a gentle wearing comfort. Yet, generally one plaster is too small, so patients with an ACD need to use two of them at the same time with a given overlap. Patients with an ACD to the patch pump will need three of the plasters at the same time because of the larger footprint of the housing. Other blister plasters than Hansaplast blister plaster did not work so well in our patients. Also, the Cutimed Hydro B plaster has been used over months with good success by two patients. This plaster consists of a silicone/hydrocolloid mixture, sticks well over a whole wearing period of 14 days, and is very gently removable. The Stomahesive baseplate can be divided into four pieces, so the costs of these additional parts are lower. This plaster is usually used in stoma patients and is based on hydrocolloids. It is thicker than the other plasters and it does not stick so firmly to the skin over 14 days. After some days, the edges crumple, and sometimes patients notice redness and some itching at these sites.
