SHORT REPORT

## Pin site allergic contact dermatitis: an unusual complication of halo fixation

We report a case of halo pin site allergic contact dermatitis, a rare complication of halo vest immobilisation (HVI), necessitating device removal. Although uncommon, pin site allergic contact dermatitis should be considered in patients who develop an acute dermatitis within hours to days of HVI application.

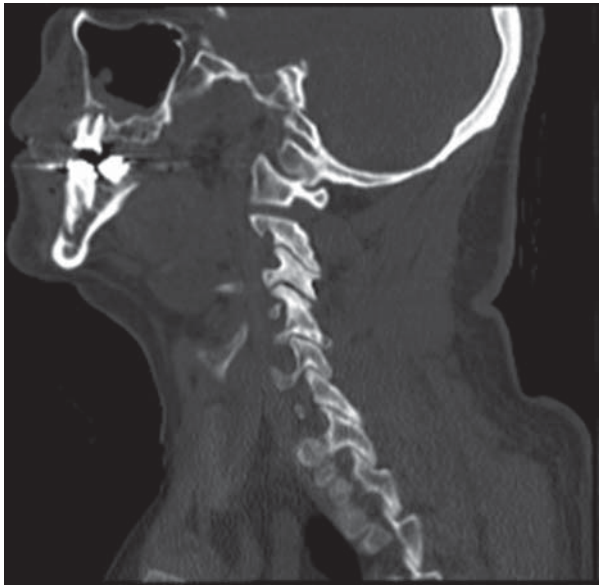
Fig. 1. Sagittal CT scan demonstrating subluxation of the left occipito-cervical joint.

A 52-year-old gentleman presented with a neck injury following a motor vehicle accident. Examination revealed some upper cervical tenderness but no neurological deficit. A computed tomography (CT) scan demonstrated an undisplaced fracture through the occipital condyle and subluxation of the left occipito-cervical joint (Fig. 1). A decision was made to treat the patient with HVI and follow-up with CT scanning of the region at intervals to assess union and alignment. A PMT Halo System, 1200 Series [PMT Corporation, Chanhassen, MN], was fitted with four titanium alloy fixation pins used to stabilise the crown, placed at standard anatomical landmarks. There was no evidence of inflammation on the skin prior to this and no breaks or abrasions to the scalp secondary to the accident.

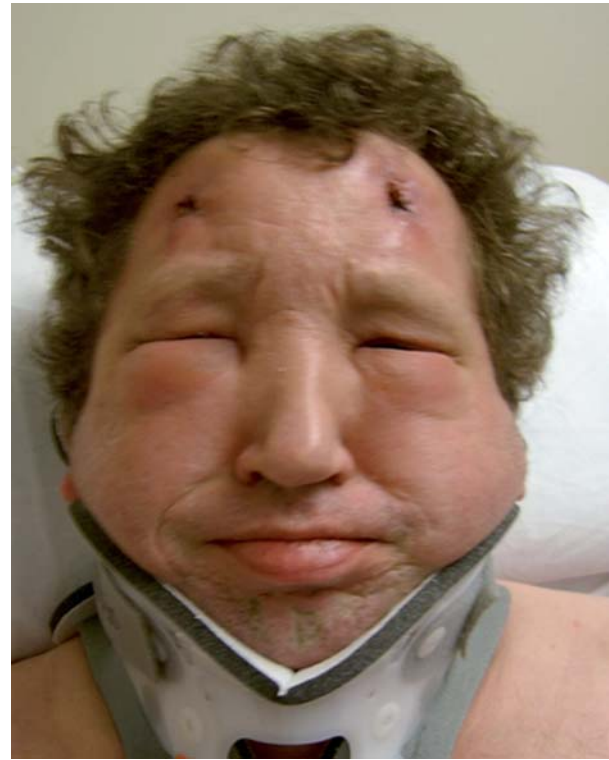
Fig. 2. Image of the patient following removal of the halo frame after 5 days, demonstrating a contact dermatitis around the forehead pins sites and periorbital oedema, which subsequently resolved

Within 72 hours of applying the halo, the patient developed bilateral periorbital oedema, progressive facial swelling and a dermatitis surrounding all four of the halo pin sites (Fig. 2). The pins were not found to be loose or altered in position. Microbiological swabs of a forehead pin site serous wound discharge were obtained and intravenous antibiotics (2 g of Flucloxacillin, four times daily) were commenced as cover against a possible pin site infection. Blood tests were significant for a C-reactive protein of 180 mg/L but were otherwise normal. The acute nature and subsequent poor clinical response to antibiotics raised the suspicion of an allergic type reaction. A decision to remove the halo was taken after

Outpatient skin patch testing to a series of metals including titanium, revealed a positive reaction to vanadium, an element found in the titanium alloy (Ti-6-Al-4V) from which the halo pins were manufactured, supporting a diagnosis of contact dermatitis. At 3 months, the patient demonstrated bony union at the site of the injury on follow-up CT scan.
